Type B Accident Investigation of the January 10, 2006, Flash Fire and Injury at the Savannah River National Laboratory

February 2006
Savannah River Operations Office
U.S. Department of Energy

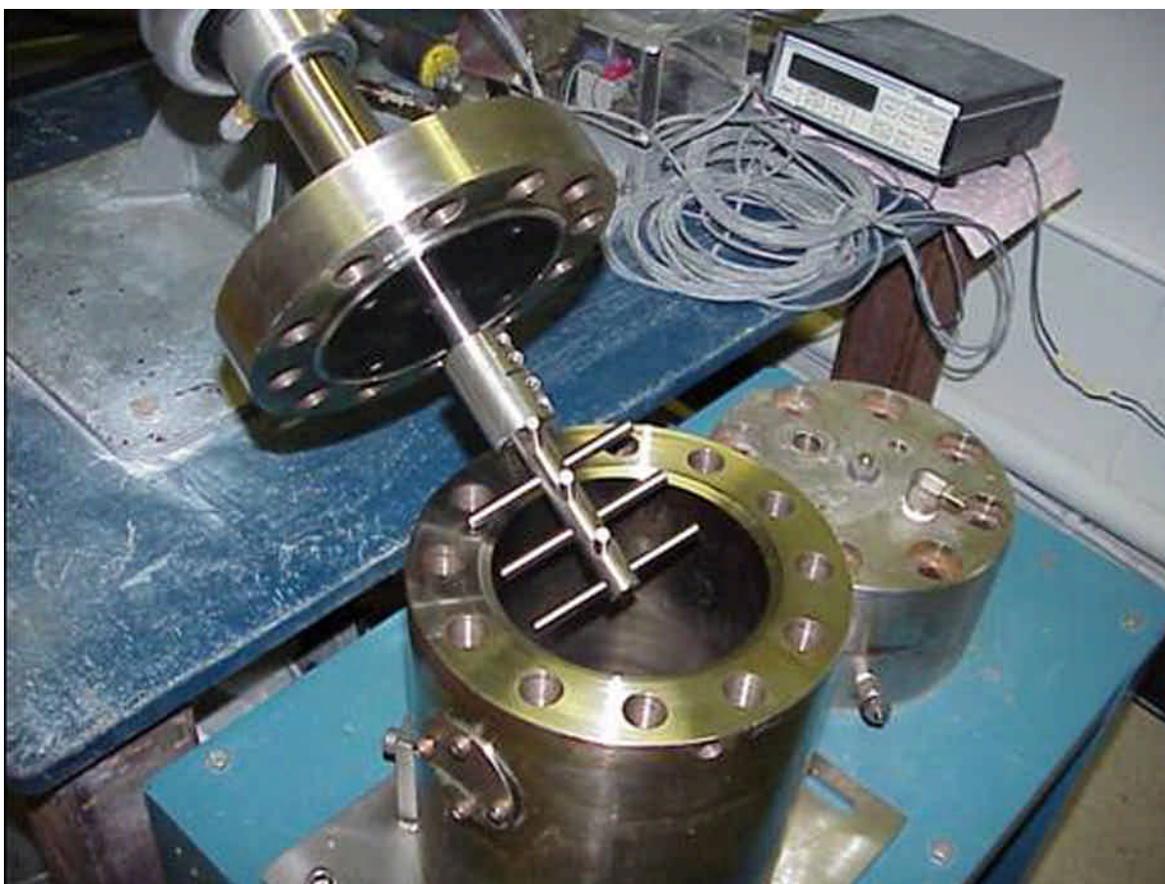
Figure 1-1. Disassembled attritor mill

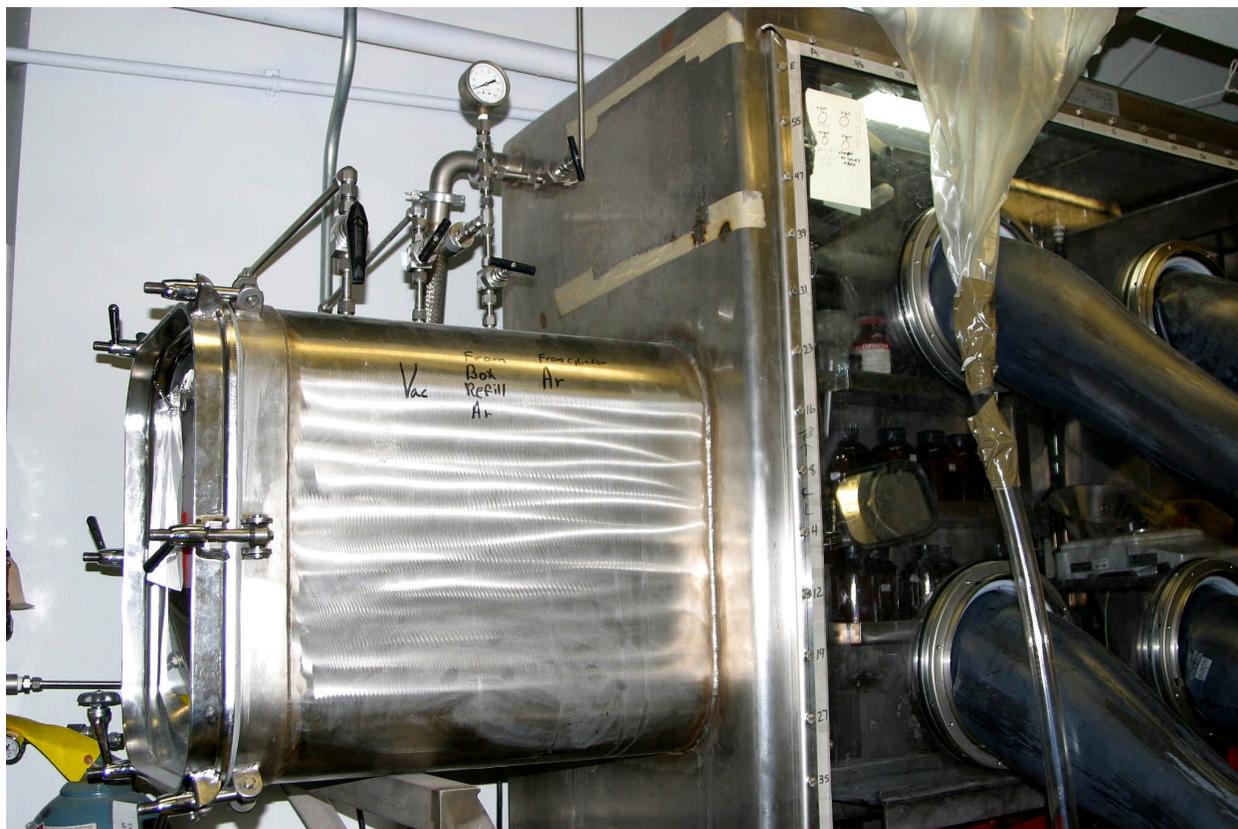
About 20 minutes into the wiping evolution, the FLM observed smoke rising from two of the boltholes. The PI wiped that area, but the smoke continued. The FLM had turned to retrieve a fire blanket when the flash fire occurred. The FLM, seeing flames on his sweater, dropped to the floor and rolled to put out the fire. Interview statements indicated that the PI smothered the flames on the vessel, wipes, and floor with MET-L-X® (an extinguishing

agent for metal fires). He then threw the fire blanket over the vessel and later put the vessel back into the glovebox antechamber. Figure 2-1 illustrates the glovebox and antechamber.

Figure 2-1. Glovebox and antechamber

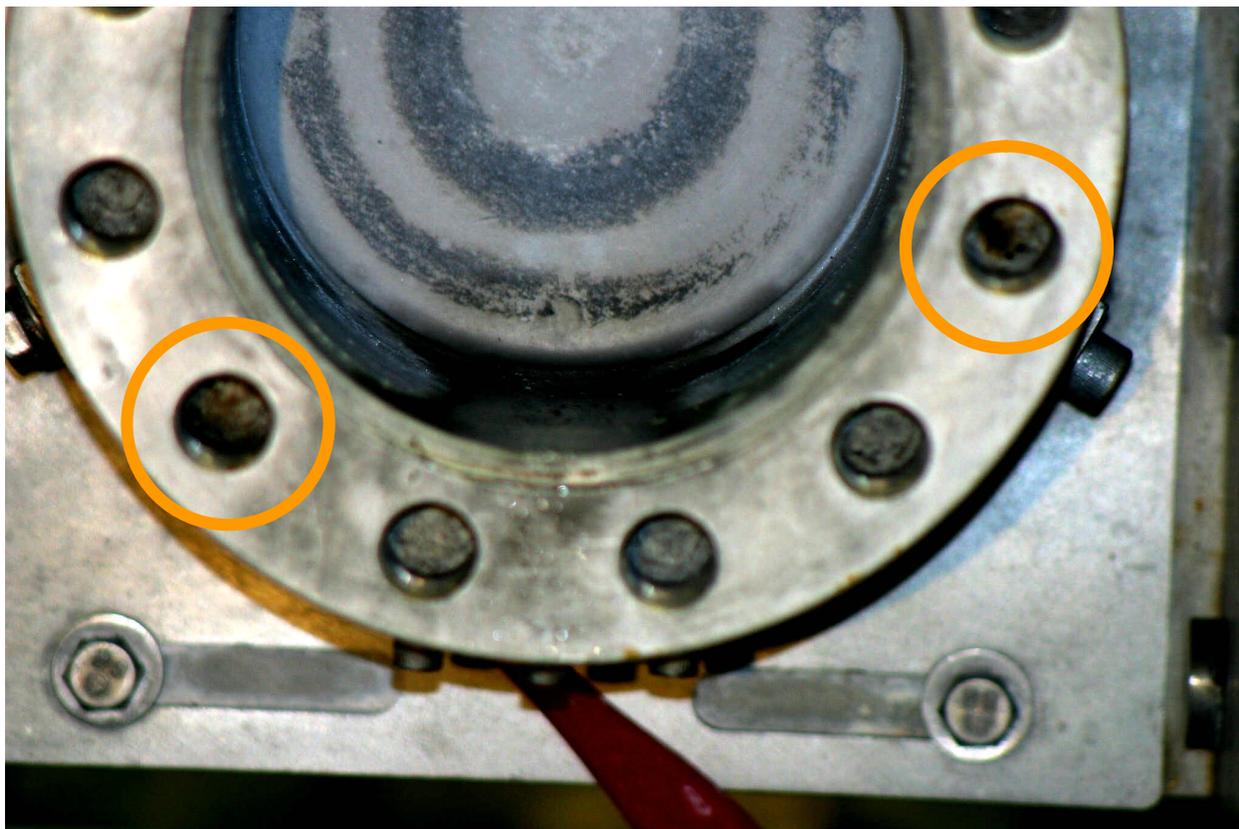
into the vessel cavity. The Board determined that material spillage during the vessel unloading process resulted in alanate material accumulating in the boltholes.

- The boltholes were not thoroughly cleaned during the passivation process.
- The FLM stated that he saw “smoke” near two of the boltholes just before the flash occurred. The Board determined that the smoke was the visible reaction product of the alanate with IPA, moisture, or air.
- Photographs and visual inspections of the attritor vessel on January 27, 2006 showed discoloration in two of the twelve boltholes (Figure 2-2), the rim, and the interior surfaces of the vessel. These surfaces had not been exposed to air during the previous attritor vessel cleanings because the attritor mill was assembled and disassembled inside the inerted glovebox.

Figure 2-2. Discoloration in the boltholes

Based upon its evaluation of the evidence, the Board determined that the reaction of air, moisture, or IPA with residual alanate in the vessel boltholes was the most likely ignition source for the alcohol vapor flash fire.
